**DEPARTMENT OF TRANSPORTATION****DIVISION OF ENGINEERING SERVICES**

Contract #: 04-0120F4Cty: SF/Ala Rte: 80 PM: 13.2/13.9File #: 69.28**WELDING INSPECTION REPORT****Resident Engineer:** Pursell, Gary**Address:** 333 Burma Road**City:** Oakland, CA 94607**Report No:** WIR-016444**Date Inspected:** 17-Aug-2010**Project Name:** SAS Superstructure**OSM Arrival Time:** 1900**Prime Contractor:** American Bridge/Fluor Enterprises, a JV**OSM Departure Time:** 700**Contractor:** Zhenhua Port Machinery Company, Ltd (ZPMC), Changxing Island **Location:** Shanghai, China**CWI Name:** See below**CWI Present:** Yes No**Inspected CWI report:** Yes No N/A**Rod Oven in Use:** Yes No N/A**Electrode to specification:** Yes No N/A**Weld Procedures Followed:** Yes No N/A**Qualified Welders:** Yes No N/A**Verified Joint Fit-up:** Yes No N/A**Approved Drawings:** Yes No N/A**Approved WPS:** Yes No N/A**Delayed / Cancelled:** Yes No N/A**Bridge No:** 34-0006**Component:** Tower and OBG Components**Summary of Items Observed:**

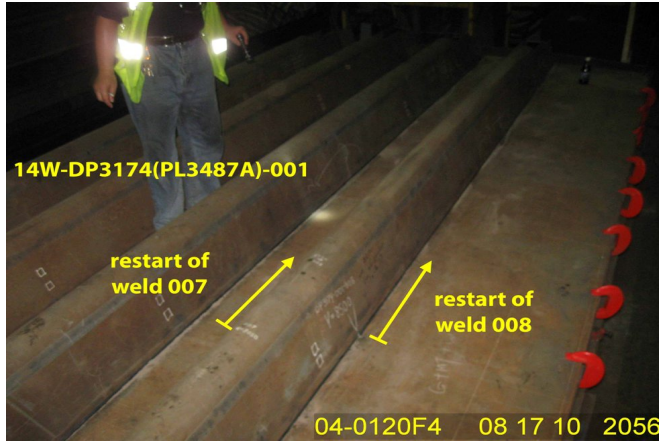
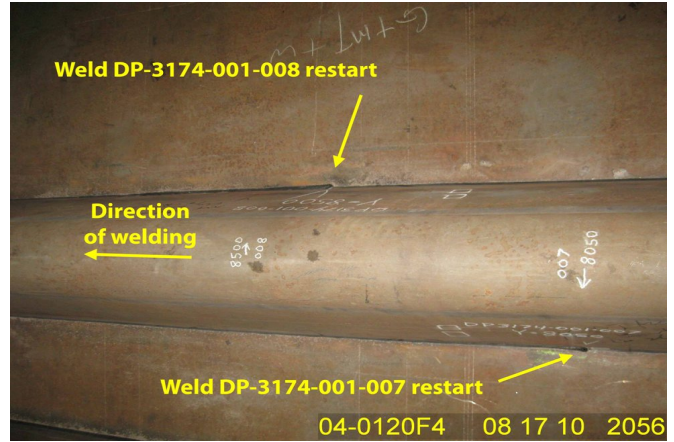
Deck panel 14W-DP3174(PL3487A)-001 was positioned on the #1 welding table and the SAW cover pass appeared to have been completed. Weld number DP3174-001-008 appeared to have been restarted at Y=8500mm and weld number DP3174-001-007 appeared to have been restarted at Y=8050mm. ABF Representative CWI Huang Wen Guang informed this QA Inspector that the SAW power supply for welding position 3 had caught fire during the production run of these 2 welds and the power supplies for welding positions 3 and 4 were shut down. The SAW pass for these 2 welds was apparently finished at a later time. This QA Inspector performed a random inspection of the welds from the above noted Y coordinates to the ends of the welds and observed no apparent indications. See photos below.
